**DEPARTMENT OF TRANSPORTATION**

Contract #: 04-0120F4Cty: SF/ALA Rte: 80 PM: 13.2/13.9File #: 69.28**WELDING INSPECTION REPORT****Resident Engineer:**Siegenthaler, Peter**Address:** 333 Burma Road**City:** Oakland, CA 94607**Report No:** WIR-025054**Date Inspected:** 20-Jun-2011**Project Name:** SAS Superstructure**OSM Arrival Time:** 1900**Prime Contractor:** American Bridge/Fluor Enterprises, a JV**OSM Departure Time:** 700**Contractor:** Zhenhua Port Machinery Company, Ltd (ZPMC), Changxing Island **Location:** Shanghai, China**CWI Name:** Mr. Li Yan Hua**CWI Present:** Yes No**Inspected CWI report:** Yes No N/A**Rod Oven in Use:** Yes No N/A**Electrode to specification:** Yes No N/A**Weld Procedures Followed:** Yes No N/A**Qualified Welders:** Yes No N/A**Verified Joint Fit-up:** Yes No N/A**Approved Drawings:** Yes No N/A**Approved WPS:** Yes No N/A**Delayed / Cancelled:** Yes No N/A**Bridge No:** 34-0006**Component:** OBG**Summary of Items Observed:**

OBG –Bay 14

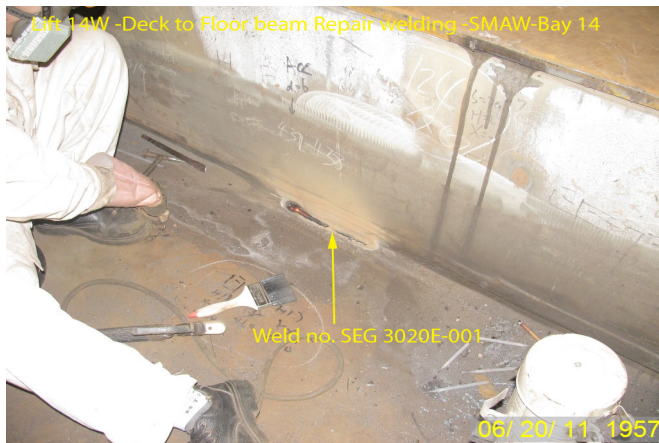
This QA inspector performed (MT) of approximately 15% of an area that has been previously tested and accepted by ZPMC Quality Control (QC) personnel. This QA Inspector generated a TL 6028 MT report for this date. The member is identified as OBG Lift 14W components. The weld designations reviewed are as follows:

SEG 3020 AZ – Jt. nos -135~162, 164~208, 210 ~259
